Bridge Vibrations Excited Through Vibro-Compaction of Bituminous Deck Pavement

R. Cantieni

rci dynamics, Structural Dynamics Consultants, Duebendorf, Switzerland

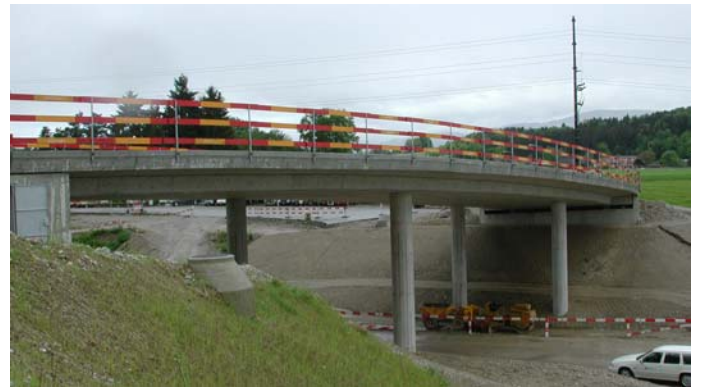
Figure 1. View of the bridge.

The tests were performed on a reinforced concrete highway bridge with spans of 17, 20 and 16 m. The cross section is a massive slab with a 0.9 m thickness and an overall (variable) width of roughly 14 m. The intermediate supports are two circular columns clamped at both ends, the abutments are basically horizontally free line bearings (Figs 1, 5, 6).

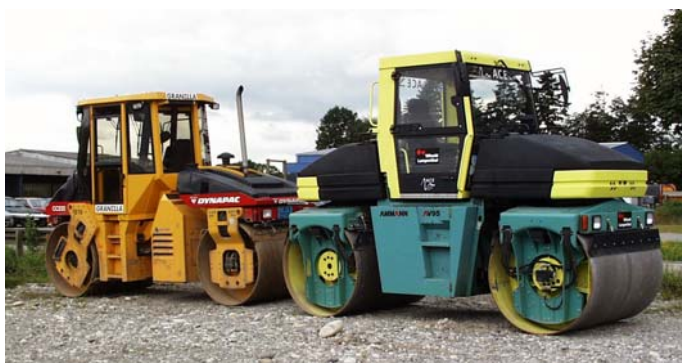
Figure 4. The rollers DY52/70 (left) and AV95 (right).

This roller has an operating mass of 9.5 t, a variable vibration frequency $f = 25 \dots 50$ Hz, a respective vibration amplitude $h = 0.62 \dots 0.1$ mm and a respective centrifugal force per drum $F = 52 \dots 7$ kN. (The vibration amplitude is related to the drum's jump height when operated on a rigid surface). In this paper, the roller is designated as "AV95" (Fig. 4).

This roller has an operating mass of 8.0 t, a vibration frequency of either $f = 52$ Hz or $f = 70$ Hz, a respective vibration amplitude of 0.5 mm and 0.22 mm and a respective centrifugal force per drum of $F = 89$ kN and $F = 65$ kN. In this paper the roller is designated as "DY52" and "DY70" respectively. In case of the vibration frequency not being an asset, the designation used is "DY52/70" (Fig. 4).

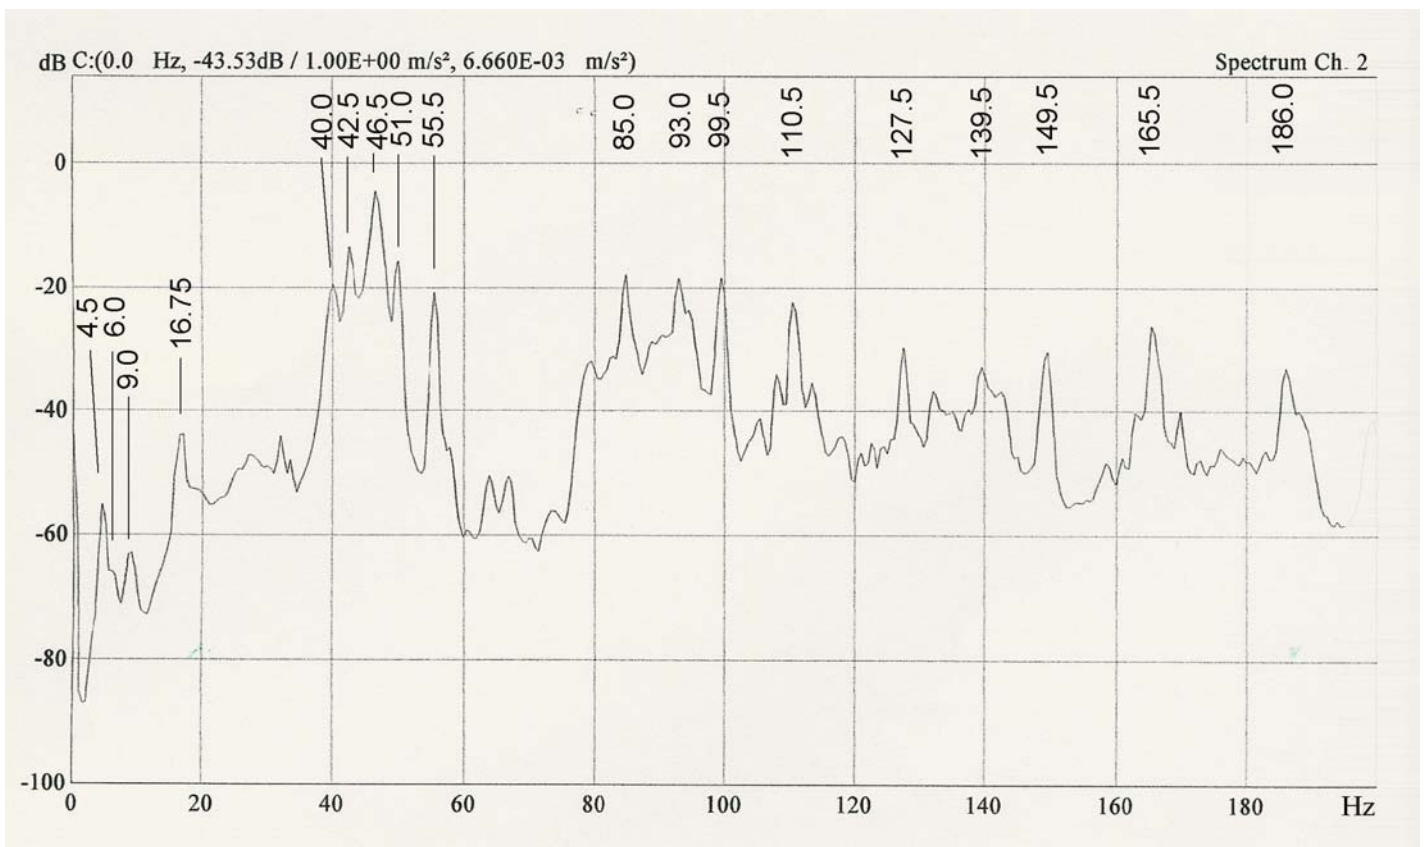
Figure 8. Frequency spectrum of the relevant part of the time signal shown in Figure 7.

Figure 7 gives an acceleration time signal recorded in measurement point No. 2 (Fig. 6). The averaged, logarithmically scaled frequency spectrum calculated from the relevant part of this signal is shown in Figure 8. What can be seen from this spectrum?

a) Four bridge natural frequencies lying in the range $f = 4.5 \dots 16.75$ Hz can be distinguished. These frequencies are $\Delta f = 0.5 \dots 1.0$ Hz lower than those determined for the bridge without pavement. This indicates that, as a consequence of the continuously increasing mass of the pavement placed on the deck the bridge natural frequencies are subject to continuous decrease.

b) Vibrations induced by the roller are in the range $f = 40 \dots 51$ Hz plus the respective higher harmonics.

c) The vibration at $f = 55.5$ Hz was first thought to be related to the bridge mode No. 9, $f = 56.6$ Hz. However, due to the existence of the related higher harmonics this interpretation had to be abandoned. This vibration could later be related to forces generated by the roller's Diesel engine.

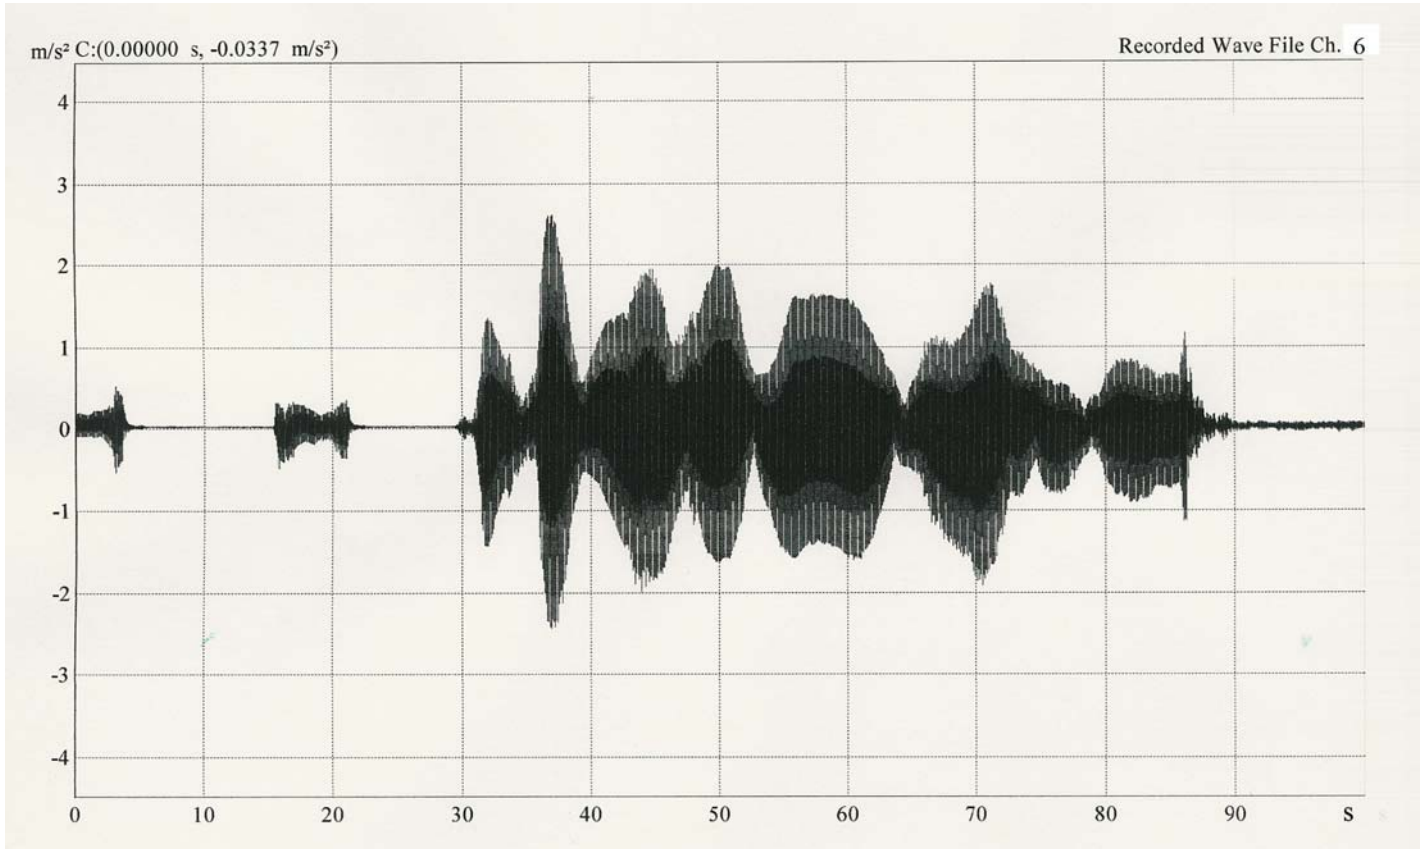
Figure 9. Acceleration time signal measured in point No. 6 during compaction with roller DY70.

Figure 9 gives an acceleration time signal recorded in measurement point No. 6. The averaged frequency spectrum calculated from the relevant part of this signal is shown in Figure 10. What can be seen from this spectrum?

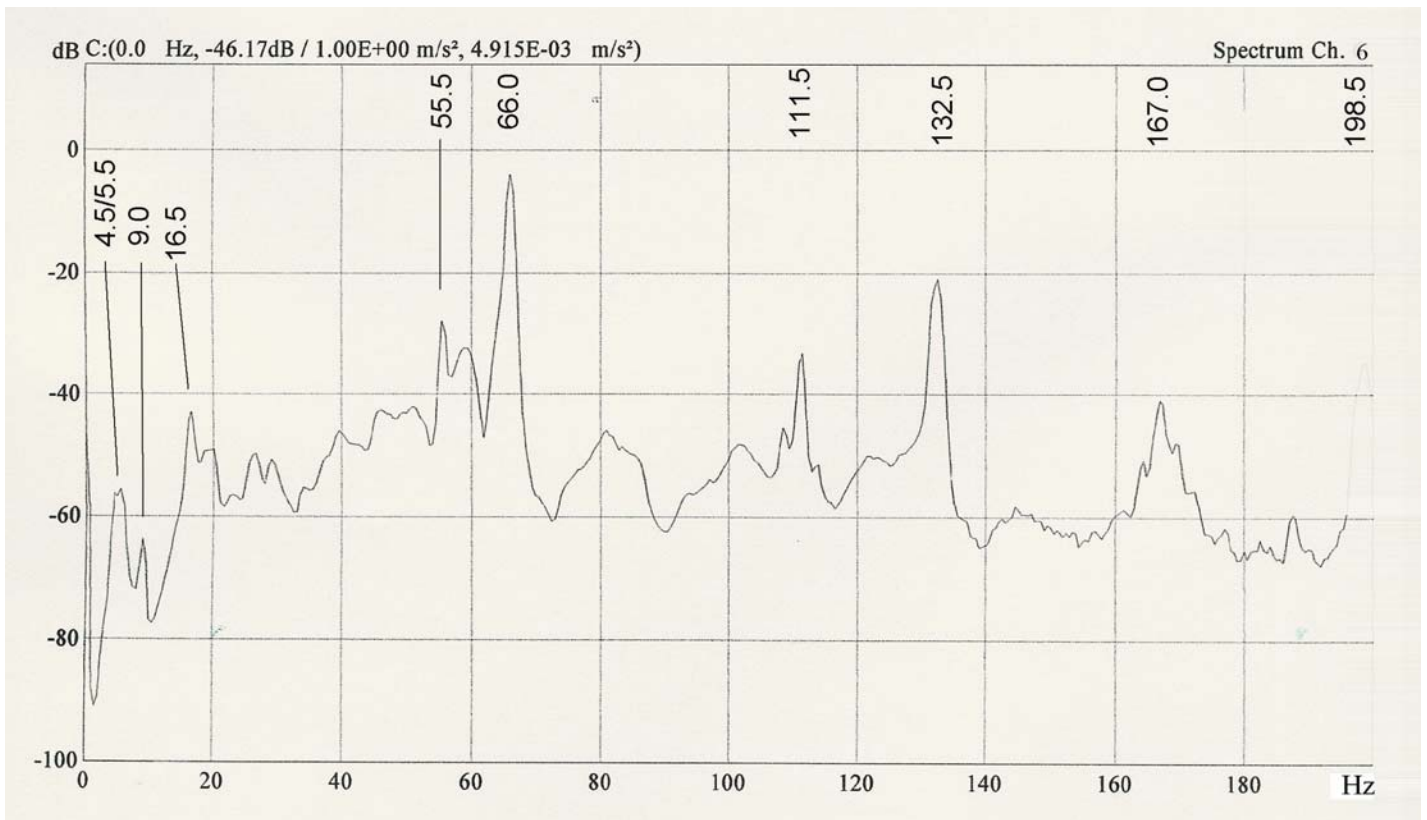
Figure 10. Frequency spectrum of the relevant part of the time signal shown in Figure 9.

a) Four bridge natural frequencies lying in the range $f = 4.5 \dots 16.5$ Hz can be distinguished. These frequencies are $\Delta f = 0.5 \dots 1.0$ Hz lower than those determined for the bridge without pavement.

b) Vibrations induced by the roller are $f = 66$ Hz plus the respective higher harmonics.

c) The Diesel engine induced vibration $f = 55.5$ Hz plus harmonics can also be identified.
